Flood Inundation in Naushahro Feroze District

Source: Landsat 8 Collection 2, 05 September 2022 5: 57 GMT

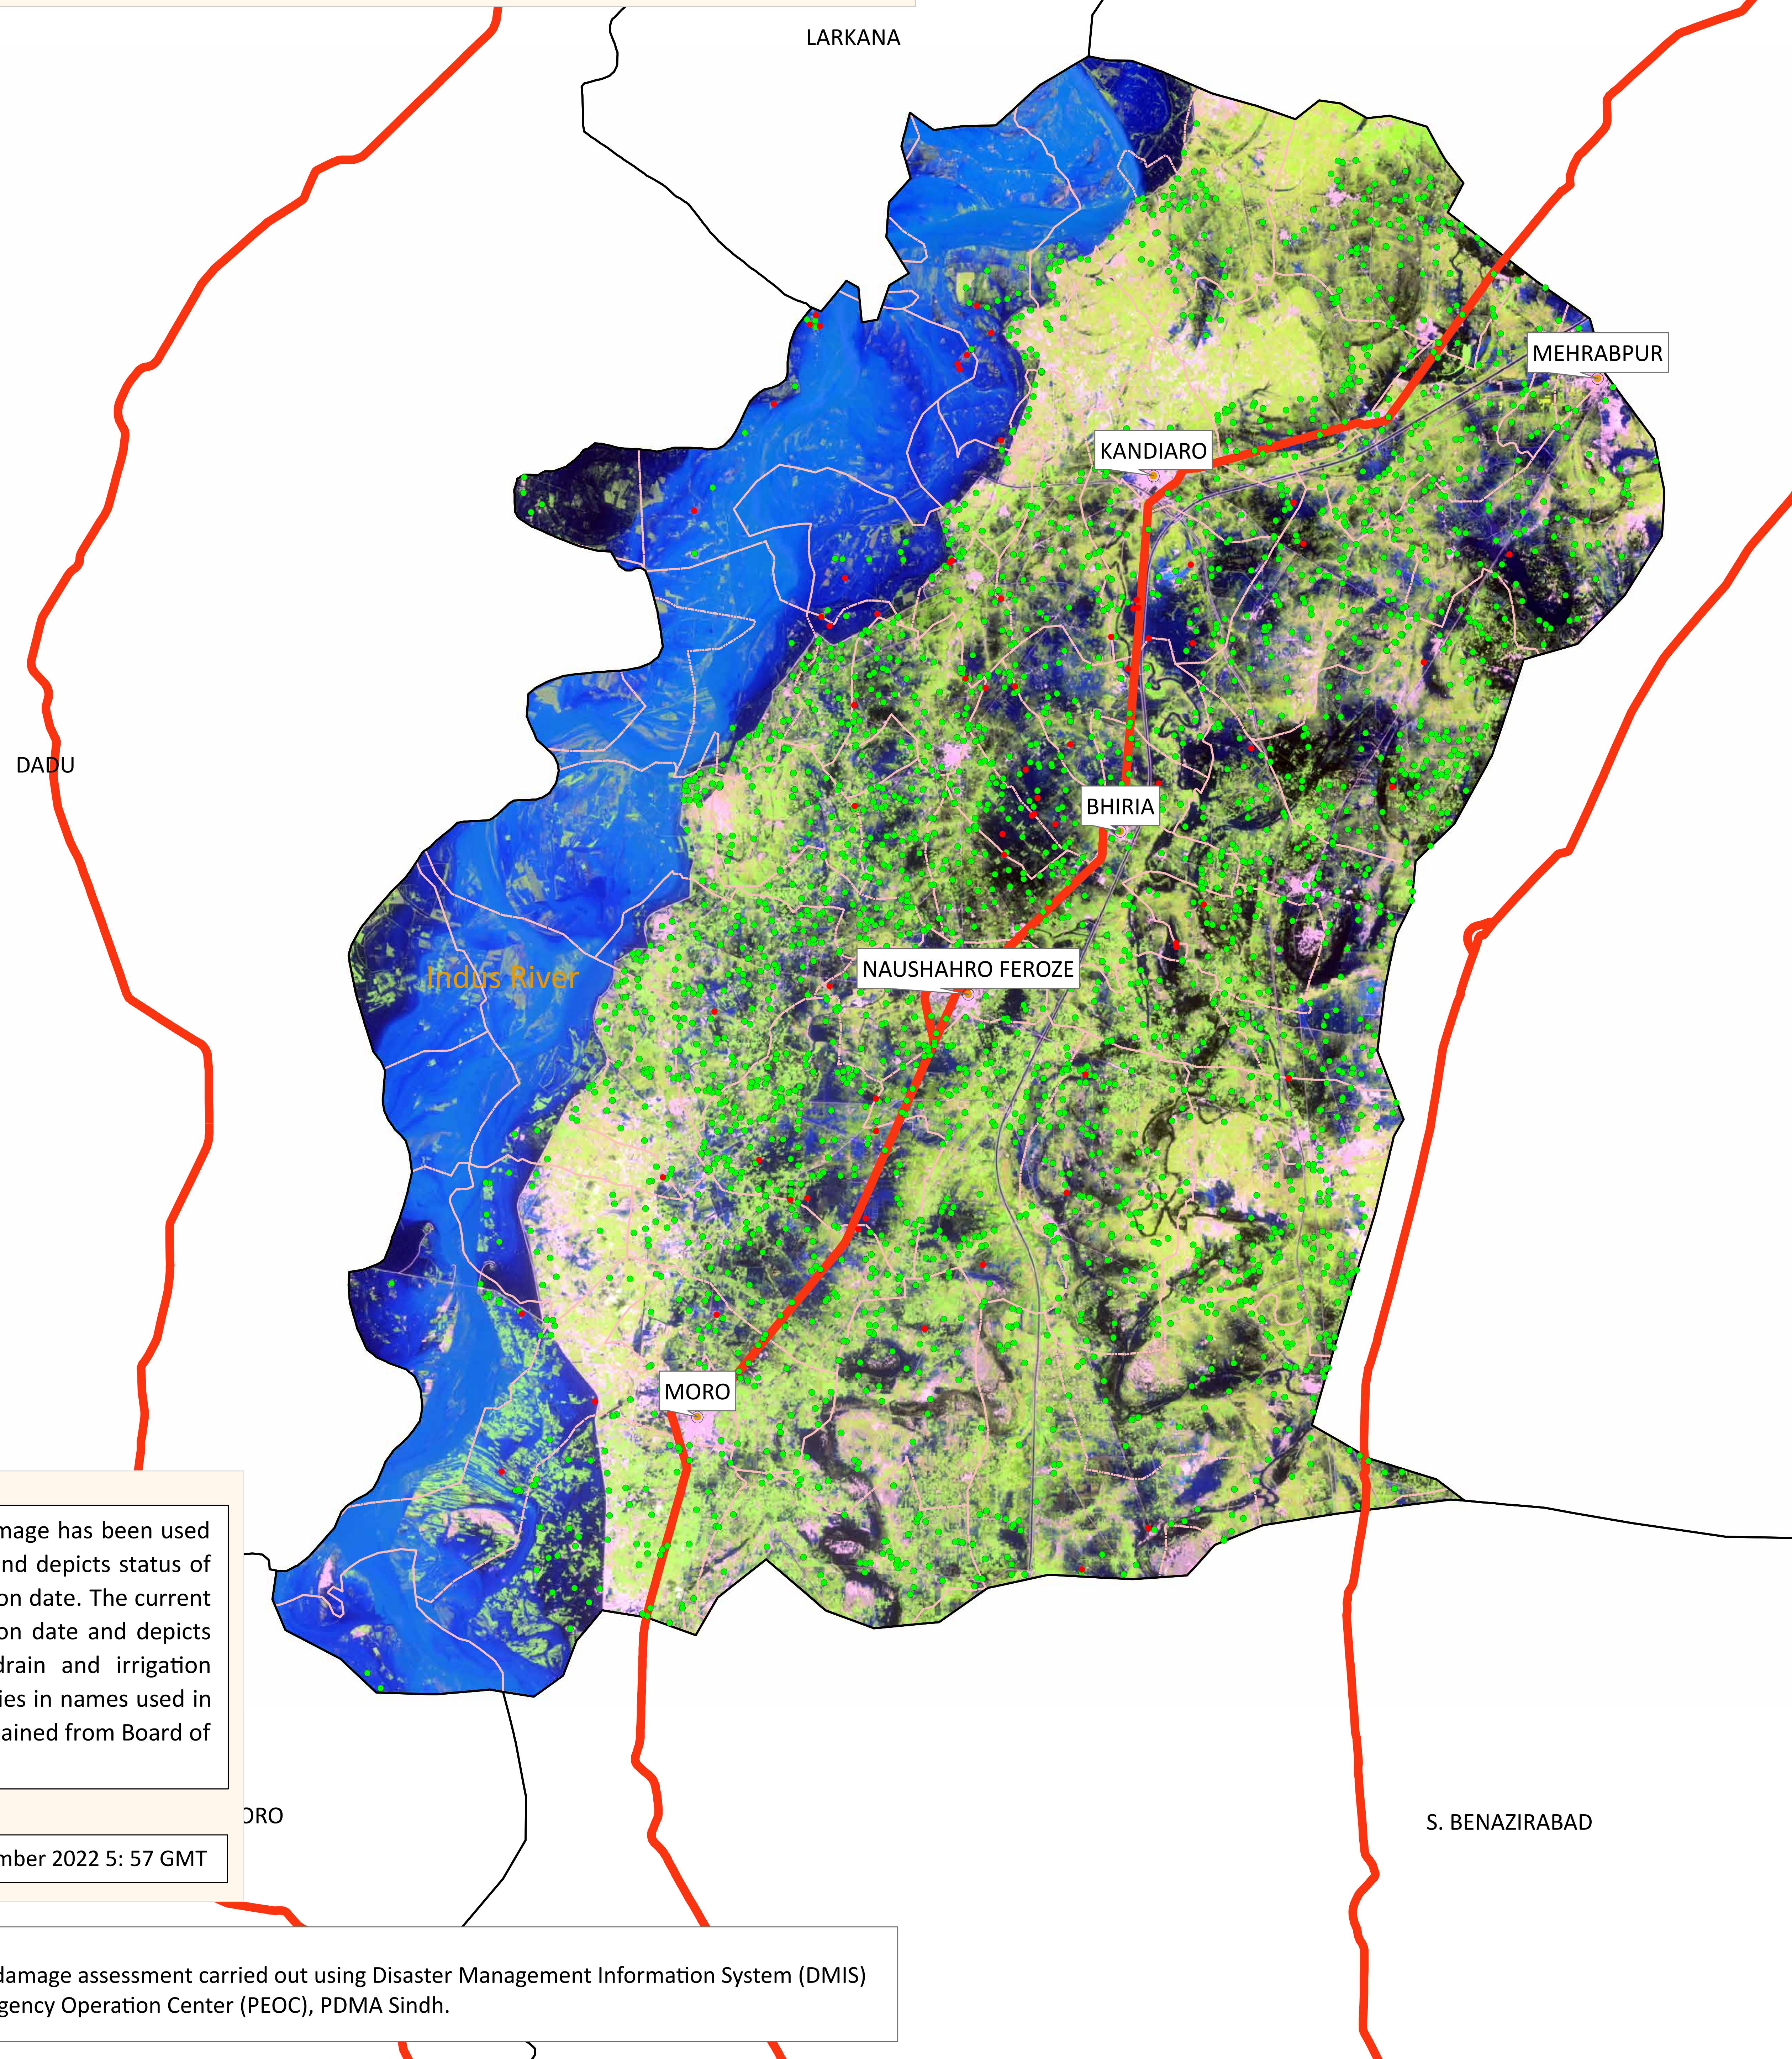
District Profile			
	28/08/2022	06/09/2022	Change
District Area	904.57 Sq.Km	3,025.48 Sq.Km	
Area Inundated	29.90%	1,005.99 Sq.Km	+101.42
Crop Land	142,452.66 Acres	596,111.6 Acres	
Crop Land Inundated	23.90%	160,754.888 Acres	+18,302.23
Rainfall (Jul-Aug)		603 mm	
Population (as per 2017 Census)		1,644,344	
Affected Union Councils	68 Out of 68	68 out of 68

Disclaimer: 30m resolution satellite image has been used for preliminary damage assessment and depicts status of flood inundation as of image acquisition date. The current situation is based on image acquisition date and depicts post breach in Left Bank Outfall drain and irrigation channels. The Union Council boundaries in names used in development of this product were obtained from Board of Revenue, Sindh.
